RE: öWOODY GUTHRIEö
DOC#: 599274
HULL#: NONE
TYPE: 32øLOD HUDSON RIVER SLOOP

SURVEY SUMMARY

**~CAPT. G. W. FULL & ASSOCIATES – MARINE SURVEYORS~
“WOODY GUTHRIE” SURVEY SUMMARY PAGE 2**

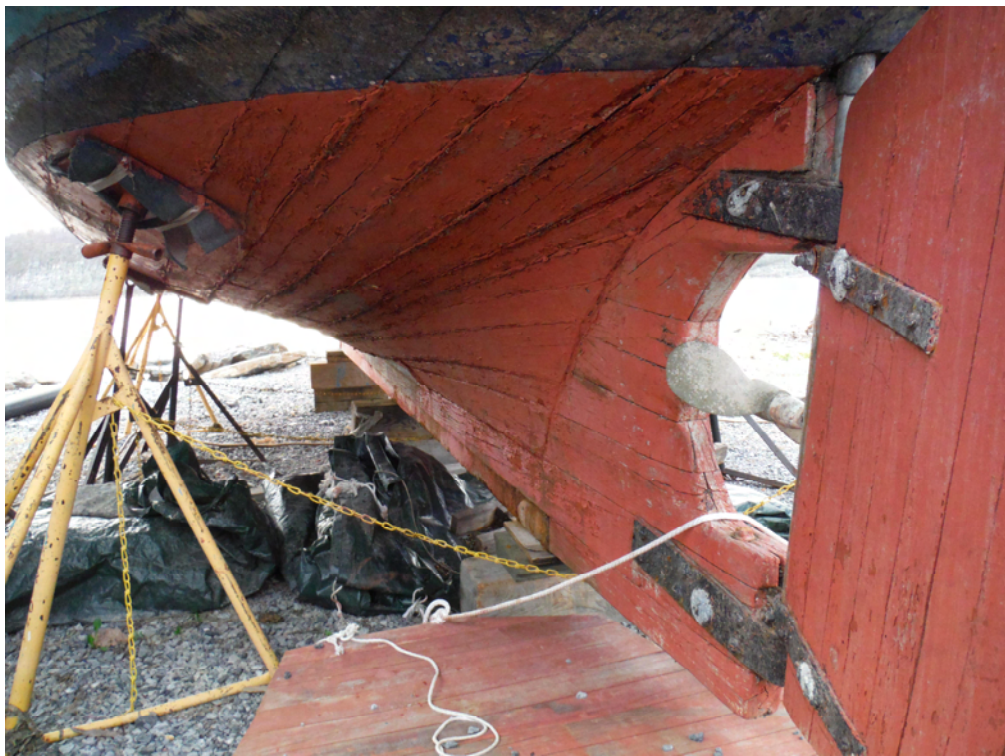
AFT VIEW OF BOTTOM 6 AGAIN NOTE SEAMS

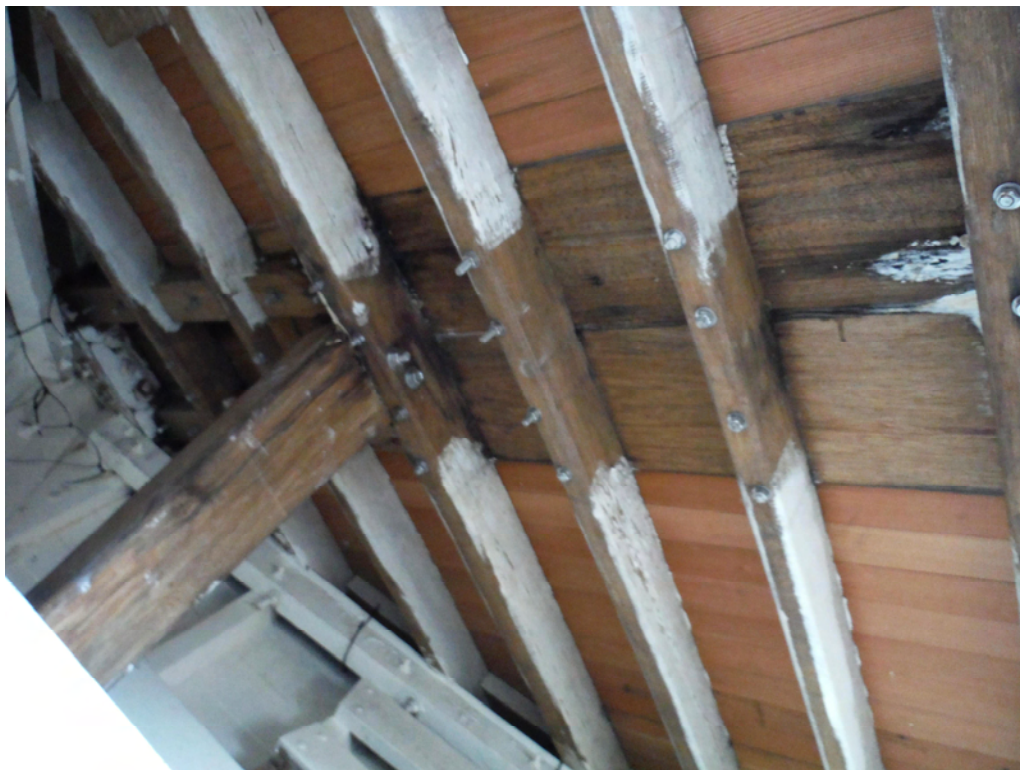
1. The underside of the king plank starting at the port side of the Sampson post and running forward is rotted, remove and replace the king plank.
2. The port Sampson post blocking is rotted at the Sampson post. This needs to be replaced.

VIEW OF UNDERSIDE OF KING PLANK 6 WHITE & BLACK AREA IS ROT
